BERKSHIRE FIRE DISTRICT NEWSLETTER

Special Publication
July 2007

Facility Background . . .

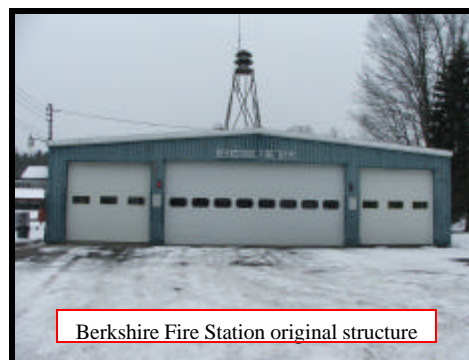
Berkshire Fire Station original structure

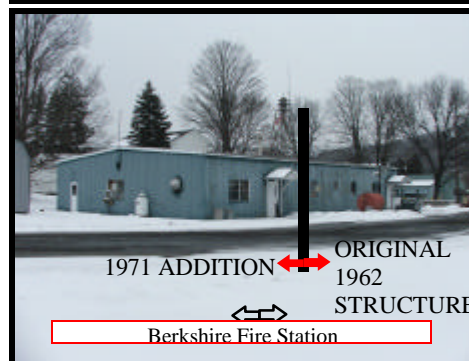
1971 ADDITION ORIGINAL 1962 STRUCTURE

The original structure was constructed in 1962 and remains substantially unchanged

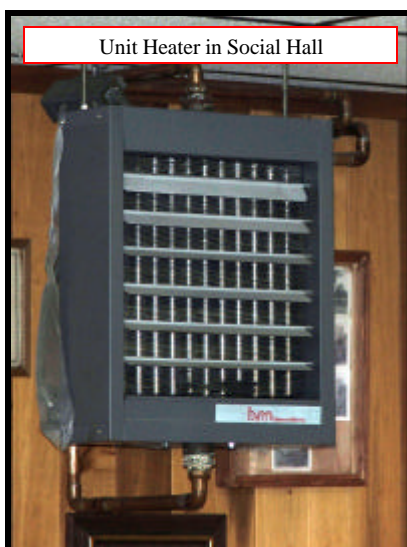
Unit Heater in Social Hall

Heat for the Social Hall is provided by an oil fired boiler located in the Apparatus Bay supplying a unit heater suspended from the ceiling in the Social Hall. There is no mechanical ventilation system in the Social Hall. There are window air conditioners for cooling.

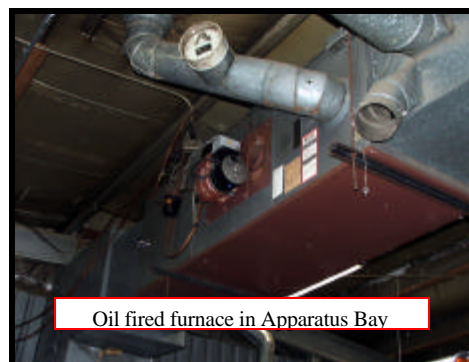
The Apparatus Bay is heated by an oil-fired furnace suspended from the structure above and it is ducted throughout the bay.

Oil fired furnace in Apparatus Bay

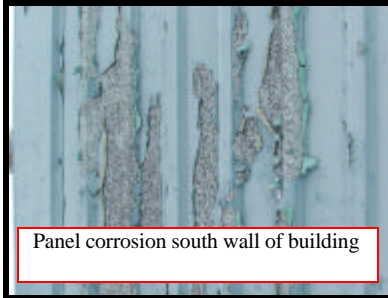
Panel corrosion south wall of building

The siding is showing signs reaching the end of its useful life as being the primary protection against weather. There are locations where rust and corrosion have eaten away at the bottom of the wall panels and have allowed mice and other rodents access into the building. These conditions have been exacerbated by the approximately 2” exposure of concrete block foundation and proximity to grade and pavement which allow rain water to splash back up onto the siding and onto the back surfaces which will accelerate the corrosion process.

The siding also has started to reject the paint. Initial review of this condition indicates that the paint as well as the steel has failed in the bonding process. The steel siding was galvanized, and it appears as though the galvanization is no longer permitting paint to adhere. This pickling of the galvanized surfaces will result in rust and corrosion in the panels if left untreated.

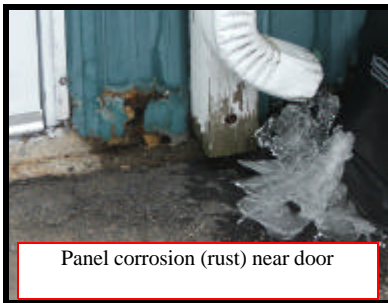
Panel corrosion (rust) near door
