BERKSHIRE FIRE DISTRICT NEWSLETTER

Special Publication
July 2007

Facility Background . . .

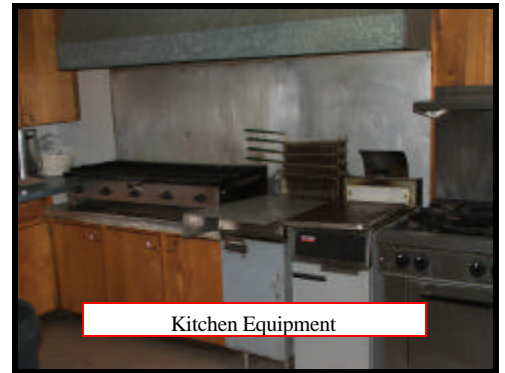
The kitchen space houses two deep fryers and a grill. The presence of any appliance in a commercial kitchen that can produce grease vapors or smoke requires that a fire suppression system

be incorporated into the exhaust hood for those pieces of equipment. The kitchen has an exhaust hood, but lacks the fire suppression system needed to conform with this requirement. Due to the need for a fire suppression system in the kitchen, all portable fire extinguishers associated with the space need to be type "K" extinguishers. One type "K" extinguisher is located in the space, but the others need to be type "K".

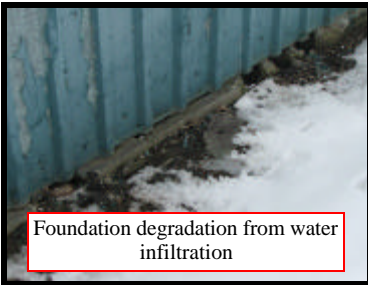
Foundation System . . . The Foundation of the facility is constructed of concrete masonry units, which are hollow core concrete or cinder blocks with occasional reinforcement. The top surface of this foundation wall is not protected from the weather and is exposed up to two inches. This exposure has caused several locations to erode away the exterior face of the block and allows water to enter into the foundation wall freely which can lead to structural failure due to freeze/thaw activity and constant exposure to moisture. The foundation wall is deteriorating more rapidly than the rest of the facility and should be addressed before much more damage occurs and the foundation begins to fail structurally. The installation of flashing at the base of the wall to divert water away from the building and off of the exposed foundation will increase the remaining life of the concrete masonry units.
